AFWAL-TR-82-2057  
Volume I

## HIGH VOLTAGE TESTING: TEST PROGRAM REPORT.

Boeing Aerospace Company  
P.O. Box 3999  
Seattle, Washington 98124

July 1982

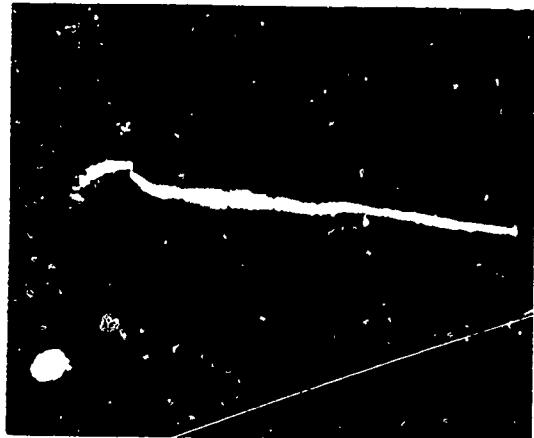
**Figure B11.** Vertical: 50 KV/div Horizontal: 2 $\mu$ sec/div  
The Last Shot of Applied Impulse Voltage to Capacitor B-2 of Approximately 210 KV. Note Just at the Peak the Waveform Breaks Up. It was Felt That This Would be About The Upper Limit For the Dielectric Hold Off.

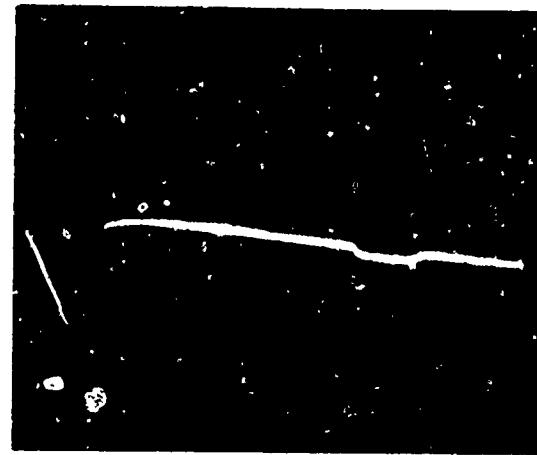
Figure B13. Vertical: 50 KV/div Horizontal: 2 $\mu$ sec/div  
The Second and Last Voltage Waveform Applied  
to B-1 with  $\approx$ 165 KV Peak.  
The Reason for the Last Shot is the Break Up of  
the Waveform Indicating That the Level is Close  
to Breakdown of the Capacitor's Dielectric.

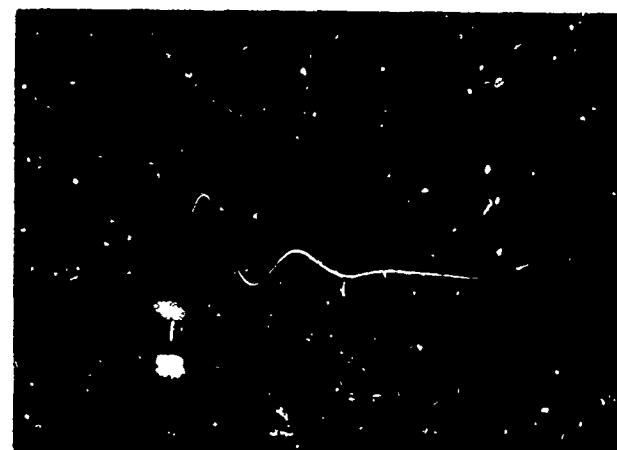
Figure B15. Vertical: 2 KV/div      Horizontal: 5 $\mu$ sec/div  
The Oscillogram of the Pulsed Voltage Waveform  
Across the C-1 , Serial #13 Capacitor,  
7 KV Peak.

Figure B15, shows a frequency riding the impulse of 100 KHz. The exact cause is not clear but the internal inductance of the two capacitors along with lead and connection inductance could be sufficient to cause the ringing noted. The equivalent capacitance would be  $6.2\mu\text{fd}$ ; with the 100 KHz signal, the inductance would be:

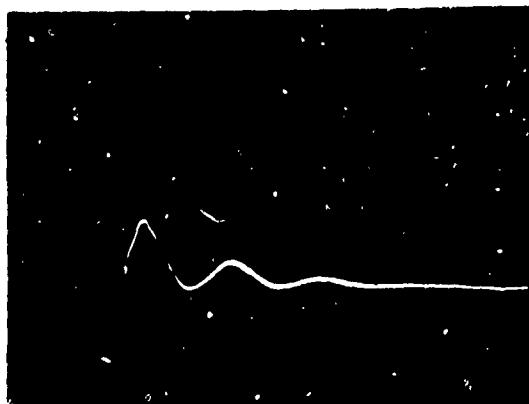
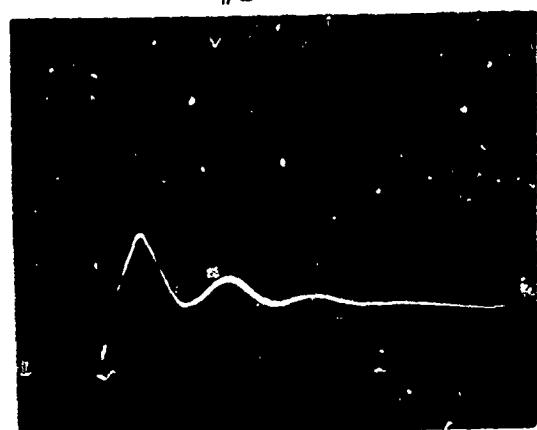
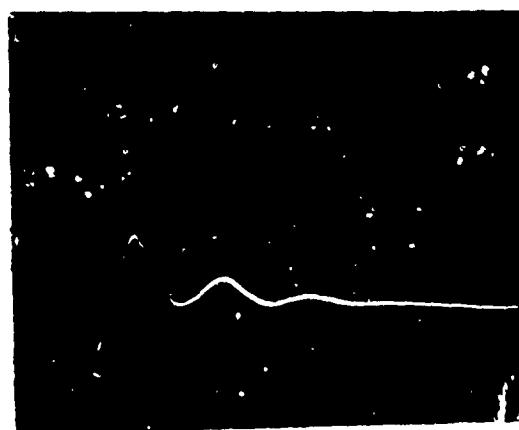
Figure 817. Vertical: 5 KV/div  
Horizontal: 5 $\mu$ sec/div

This Series of Oscilloscopes Shows  
the Waveforms of the Impulse Voltage  
Applied to the C-1  
Serial #13 Capacitor with the Same  
Charge Voltage Each Shot. No  
Noticeable Deterioration in Waveform  
Was Noted After the 5 Shots - Voltage  
Peak = 14.5 KV.
